Repair Report

County Ditch 77

Renville County, Minnesota

ISG Project No.: 14-16717

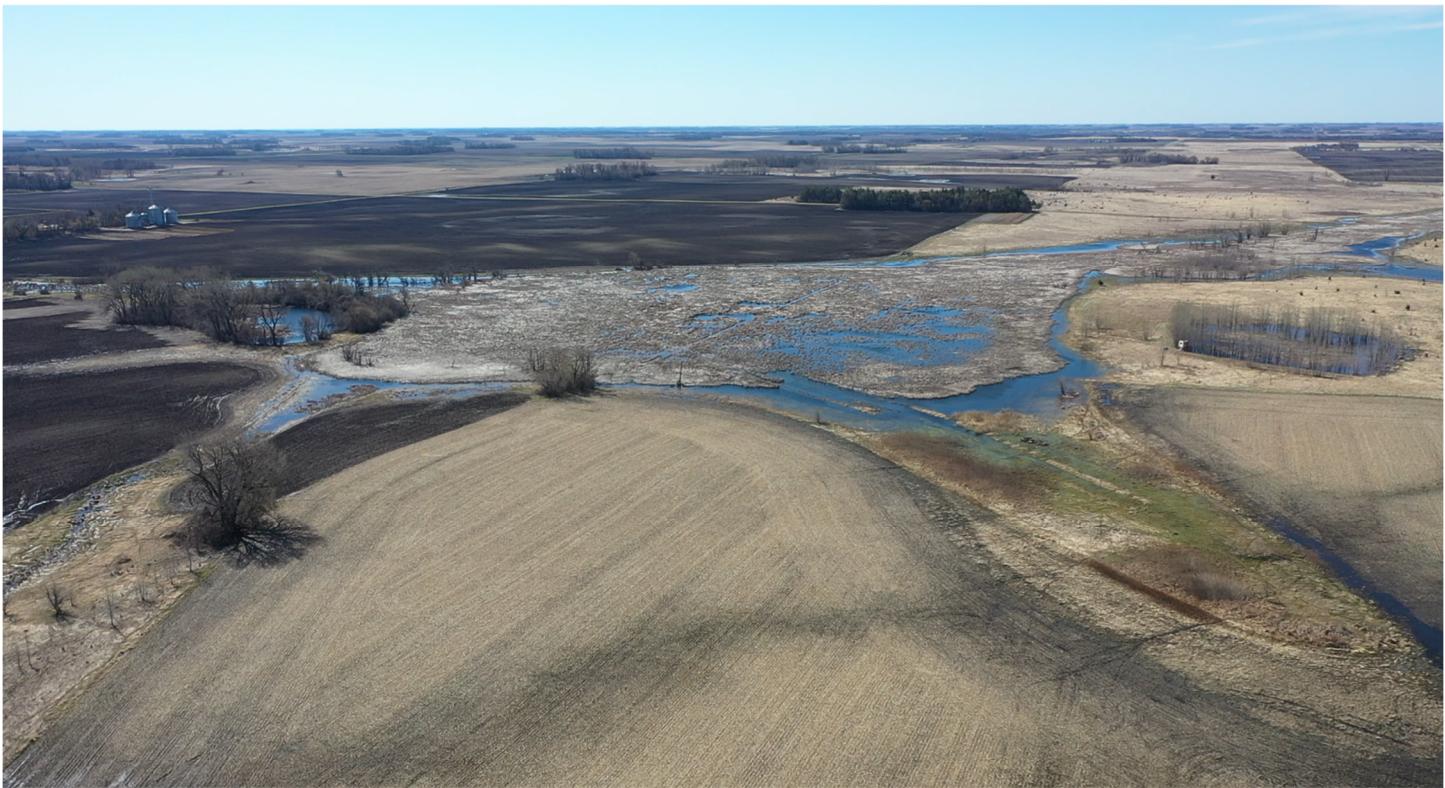
Wetland complexes are scattered throughout the Limbo Creek watershed which provide storage and water quality benefits to the creek. One of these wetland complexes surrounds the outflow of CD77 and stretches downstream around the private ditch and altered portion of Limbo Creek in Section 11. This wetland over time has expanded from historic conditions as the private ditch and downstream watercourse was not maintained. It consists of dense cattails and small pockets of open water. The cattails have restricted flow causing sediment to accumulate through this stretch of the watercourse. This has caused extensive flooding on the edges of the wetland into the adjacent uplands that has not historically existed. This wetland is shown below in Figure 1.

Figure 1. Wetland at CD77 Outlet in Section 11

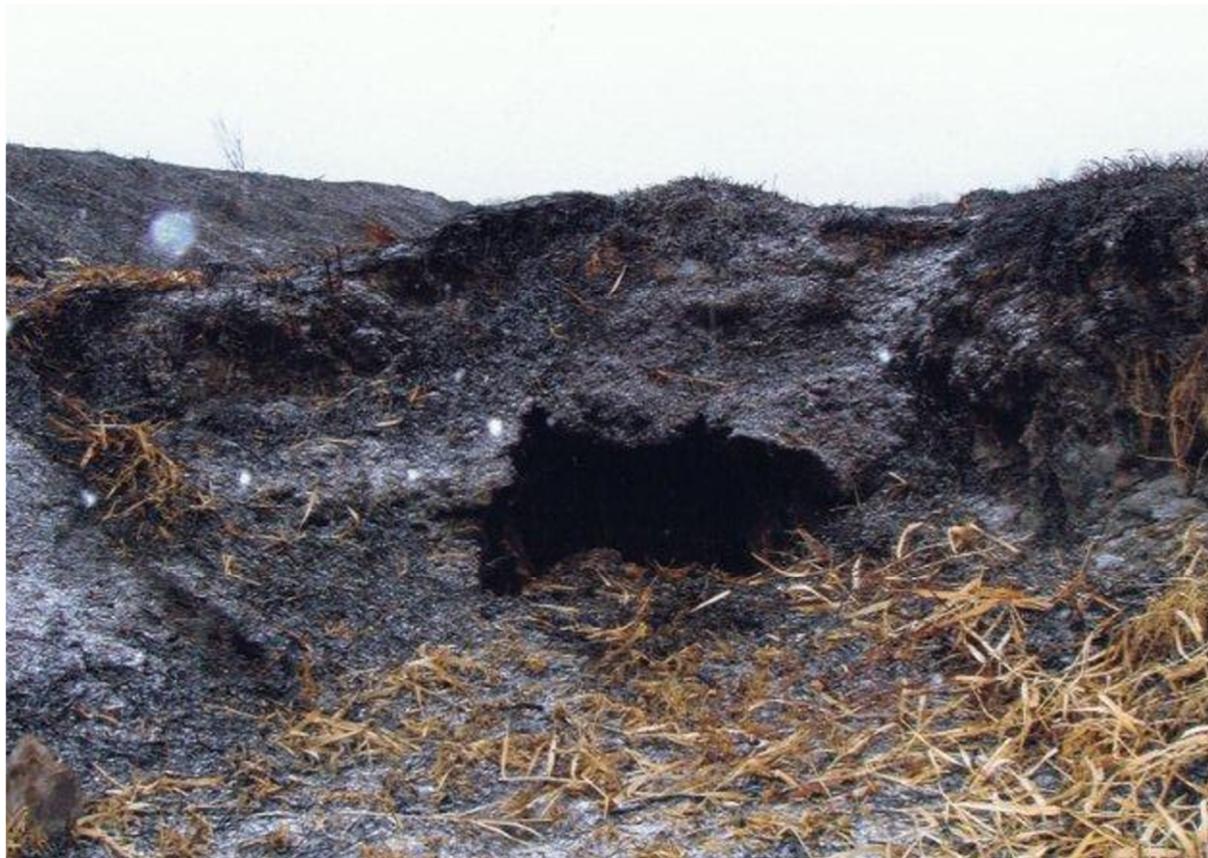
The topographic and drone surveys revealed significant sediment deposition in the main channel of Limbo Creek downstream of its junction with CD77. In some cases, the accumulated sediment is more than 4 feet higher than the culvert invert elevations and 2 feet higher than the CD77 tile outlet invert (see Figure 2). The sediment depths were calculated based on soil boring performed jointly with the DNR along the altered portion of the channel between 820th Avenue and CSAH 10. It was also observed that the sediment deposits in the channel, a dense monoculture of cattails in and around the channel (Figures 3 & 4), and gravel from the road overtopping accumulated in the channel have caused flow restrictions.

Figure 2. Sediment Covering the CD77 Mainline Tile Outlet

The Renville County Ditch 77 outlet is currently severely restricted from its originally constructed outlet. The tile outlet is frequently underwater and clogged with sediment due to wetland water levels. This restriction increases flooding upstream in the CD77 watershed. To repair these drainage issues, a pump system is proposed at the Mainline tile outlet of CD77 to provide an unrestricted outlet. The pump will be limited to the ACSIC capacity of the CD77 Mainline tile outlet. The estimated cost of the proposed repair is \$185,383.

The proposed repair will install a lift station at the outlet of the Mainline tile that will be limited to the same capacity as the originally constructed or ACSC mainline. This repair will provide an outlet for CD77 that matches the historic and legal flow conditions of the tile. The proposed repair is estimated to cost \$185,383

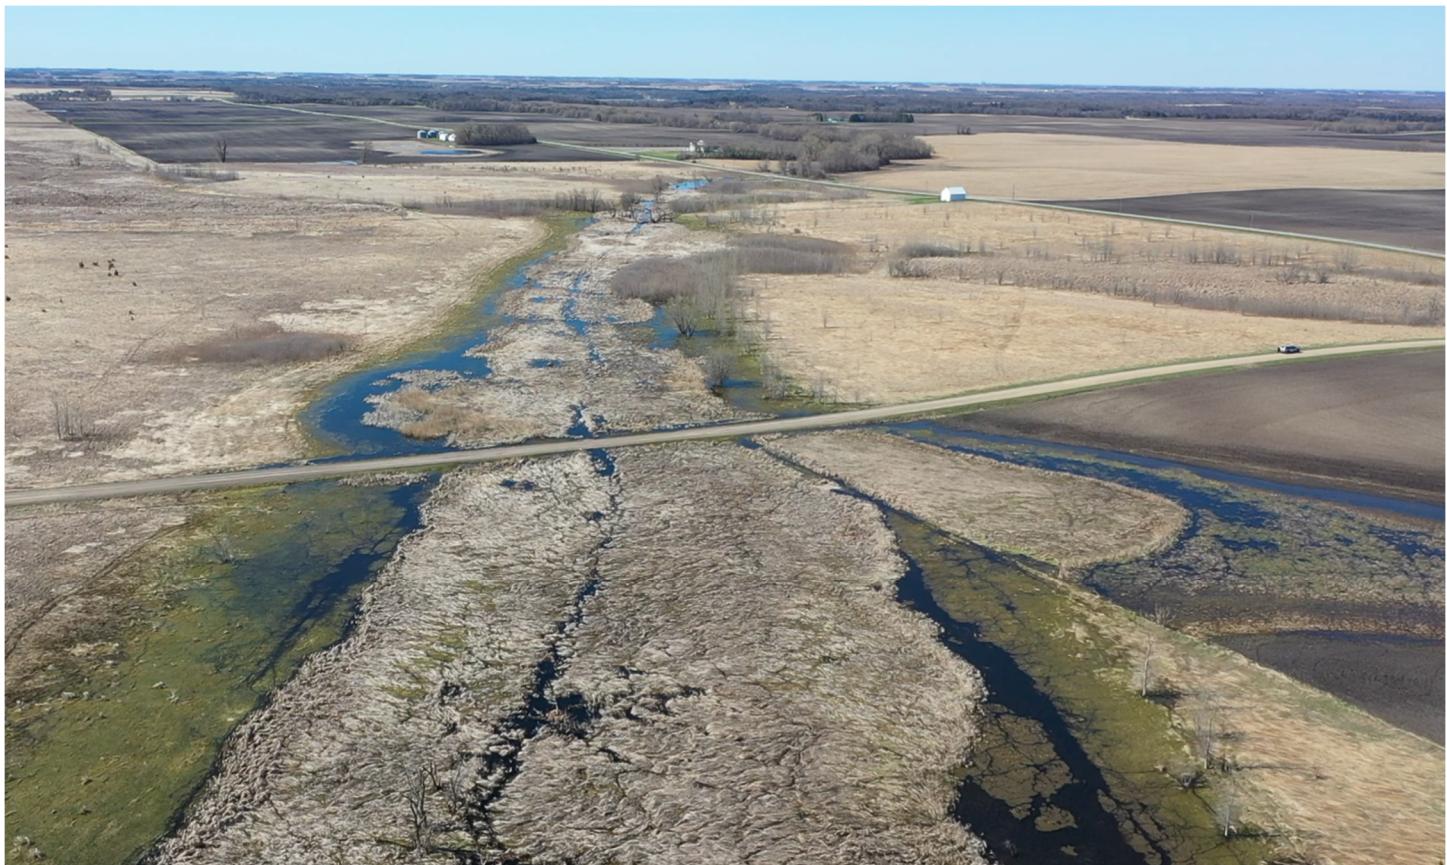
Figure 3. Drone Aerial of 820th Avenue (2019)

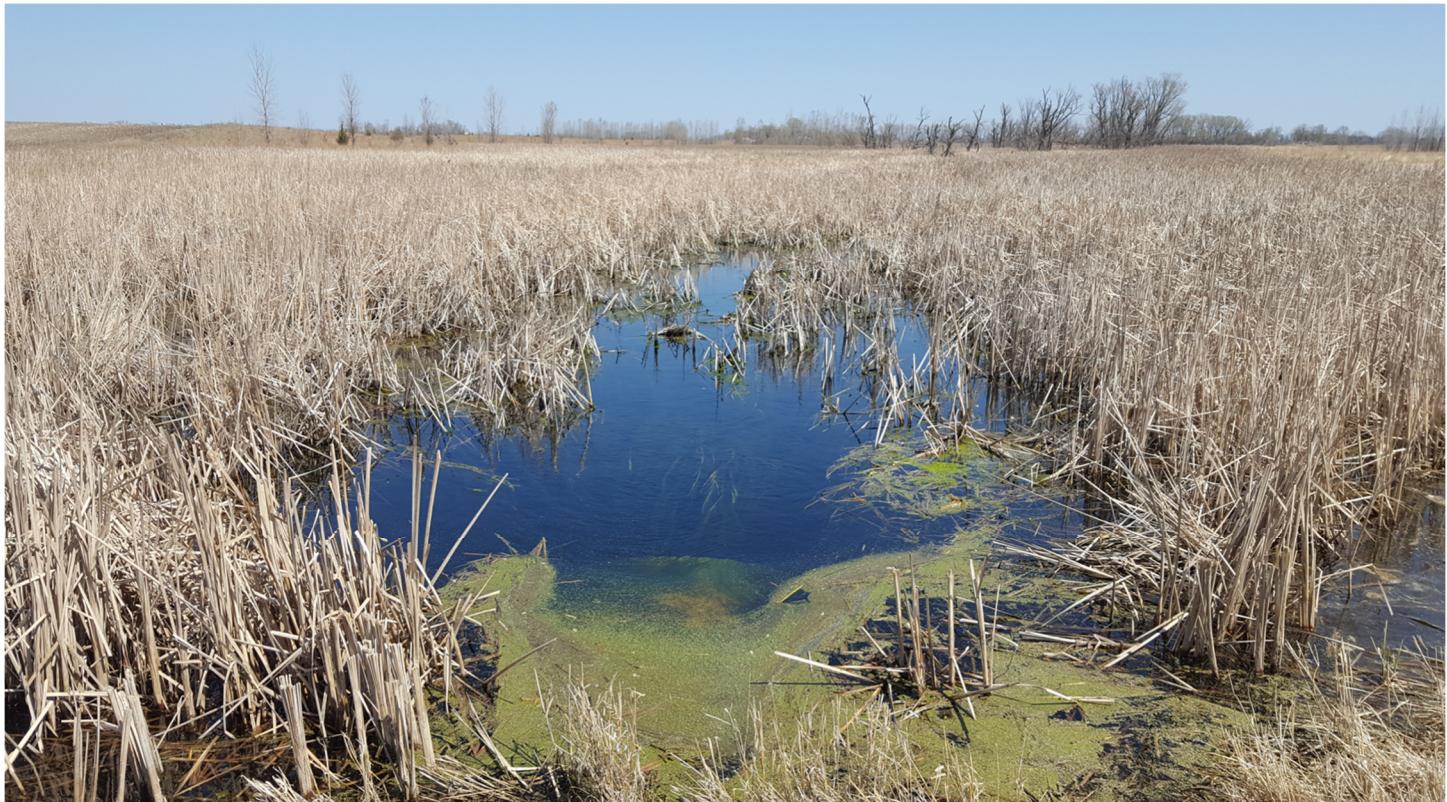
Figure 4. 820th Avenue Culvert (2018)

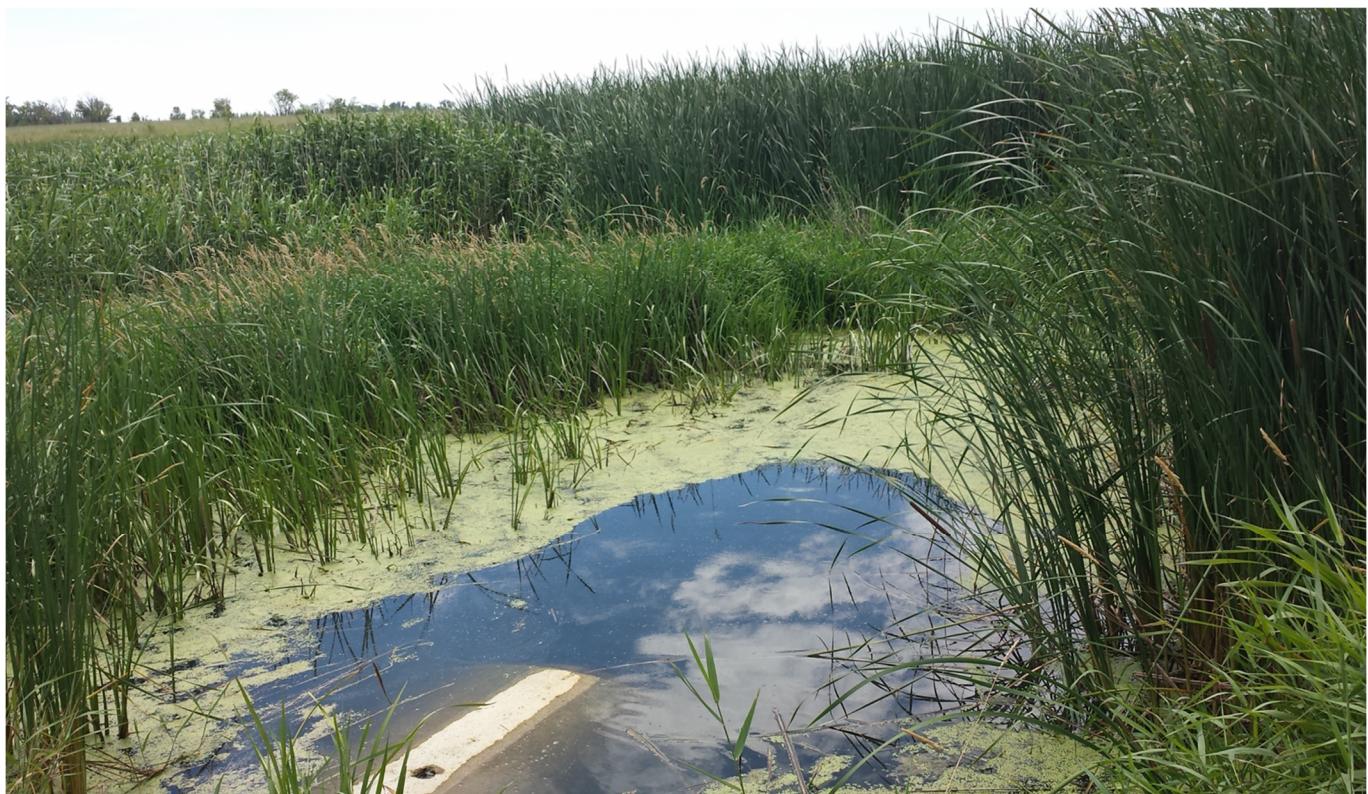
Currently the flow at this crossing is severely restricted by the downstream sediment/gravel that has built up to the top of the culvert elevation (Figure 5). Approximately 95% of the flow to this point is runoff through the Limbo Creek watercourse. The flow passes through the roadway by either building up enough head pressure to force water laterally around the channel, or the flow over tops the roadway and causes additional sediment and gravel buildup within the channel. Cleaning this stretch is not necessary for the CD 77 pump repair, however it will provide more baseflow to pass through the culvert and reduce the risk of the roadway overtopping and furthermore public safety concerns.

Figure 5. 820th Avenue Culvert Low Flow Blocked by Downstream Sediment/Gravel Buildup

In addition to the repair, it is recommended to clean 300 linear feet of open channel downstream of the 820th Ave culvert. This work is recommended because sediment and gravel has built up to 4 feet above the invert of the culvert. This blockage increases the frequency at which the road overtops which has led to erosion and public safety concerns. This work is recommended to alleviate those concerns and to provide a minimally intrusive solution to restore hydrology to the waterway. The cost of the open channel cleaning is estimated at \$47,546.

The estimate repair cleaning cost for the 300-foot stretch downstream of 820th Avenue is \$47,546.
